EG&G ROCKY FLATS
ENVIRONMENTAL MANAGEMENT DEPARTMENT
ASSESSMENT OF KNOWN, SUSPECT, AND POTENTIAL
ENVIRONMENTAL RELEASES OF
POLYCHLORINATED BIPHENYLS (PCBs)

PRELIMINARY ASSESSMENT/SITE DESCRIPTION

October 1991

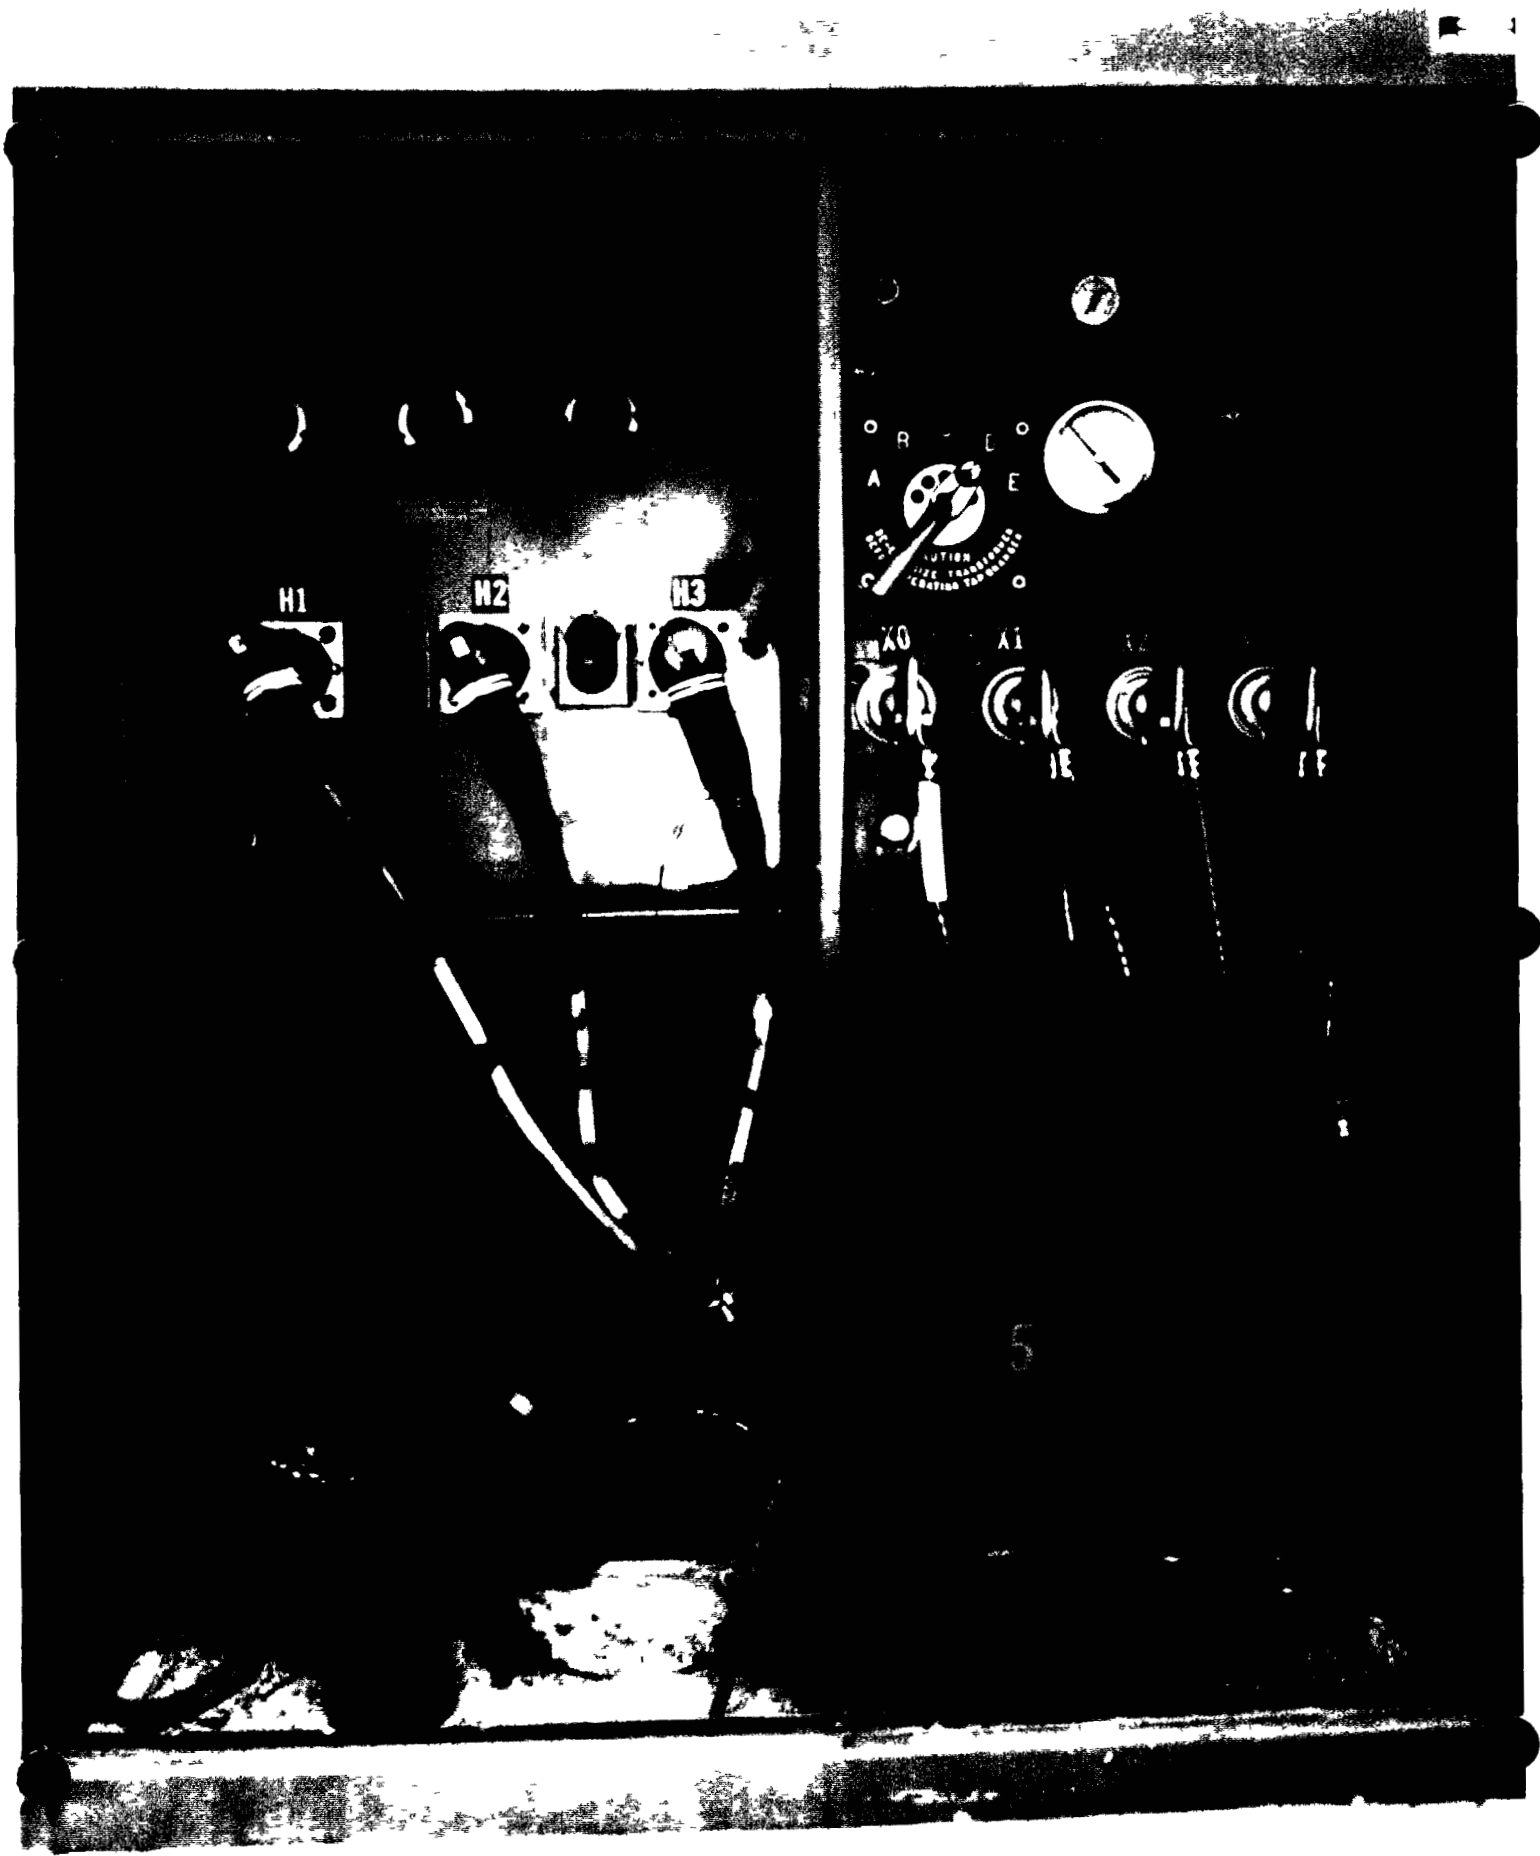
SITE #3 - Northeast of Building 551

Transformer T556 exists at this location on a concrete pad 20 feet east of building 551 within a bermed pad. The pad was constructed over an area on which a different transformer with no pad was located. Transformer T556 was retro-filled in 1987. This transformer is known to have leaked oil containing PCBs directly onto the soil beneath it according to discussions with personnel from Utilities (Photo #3). No documented remedial measures were initiated at this site. Transformer T556 continues to leak as evidenced by the stains on the pad in place and fresh oil present inside the east panel. This site is approximately forty feet south of IHSS 158, approximately forty feet west of IHSS 117 2 and adjacent to the northeast corner of Building 551.

Site #3 is prioritized as a Category II

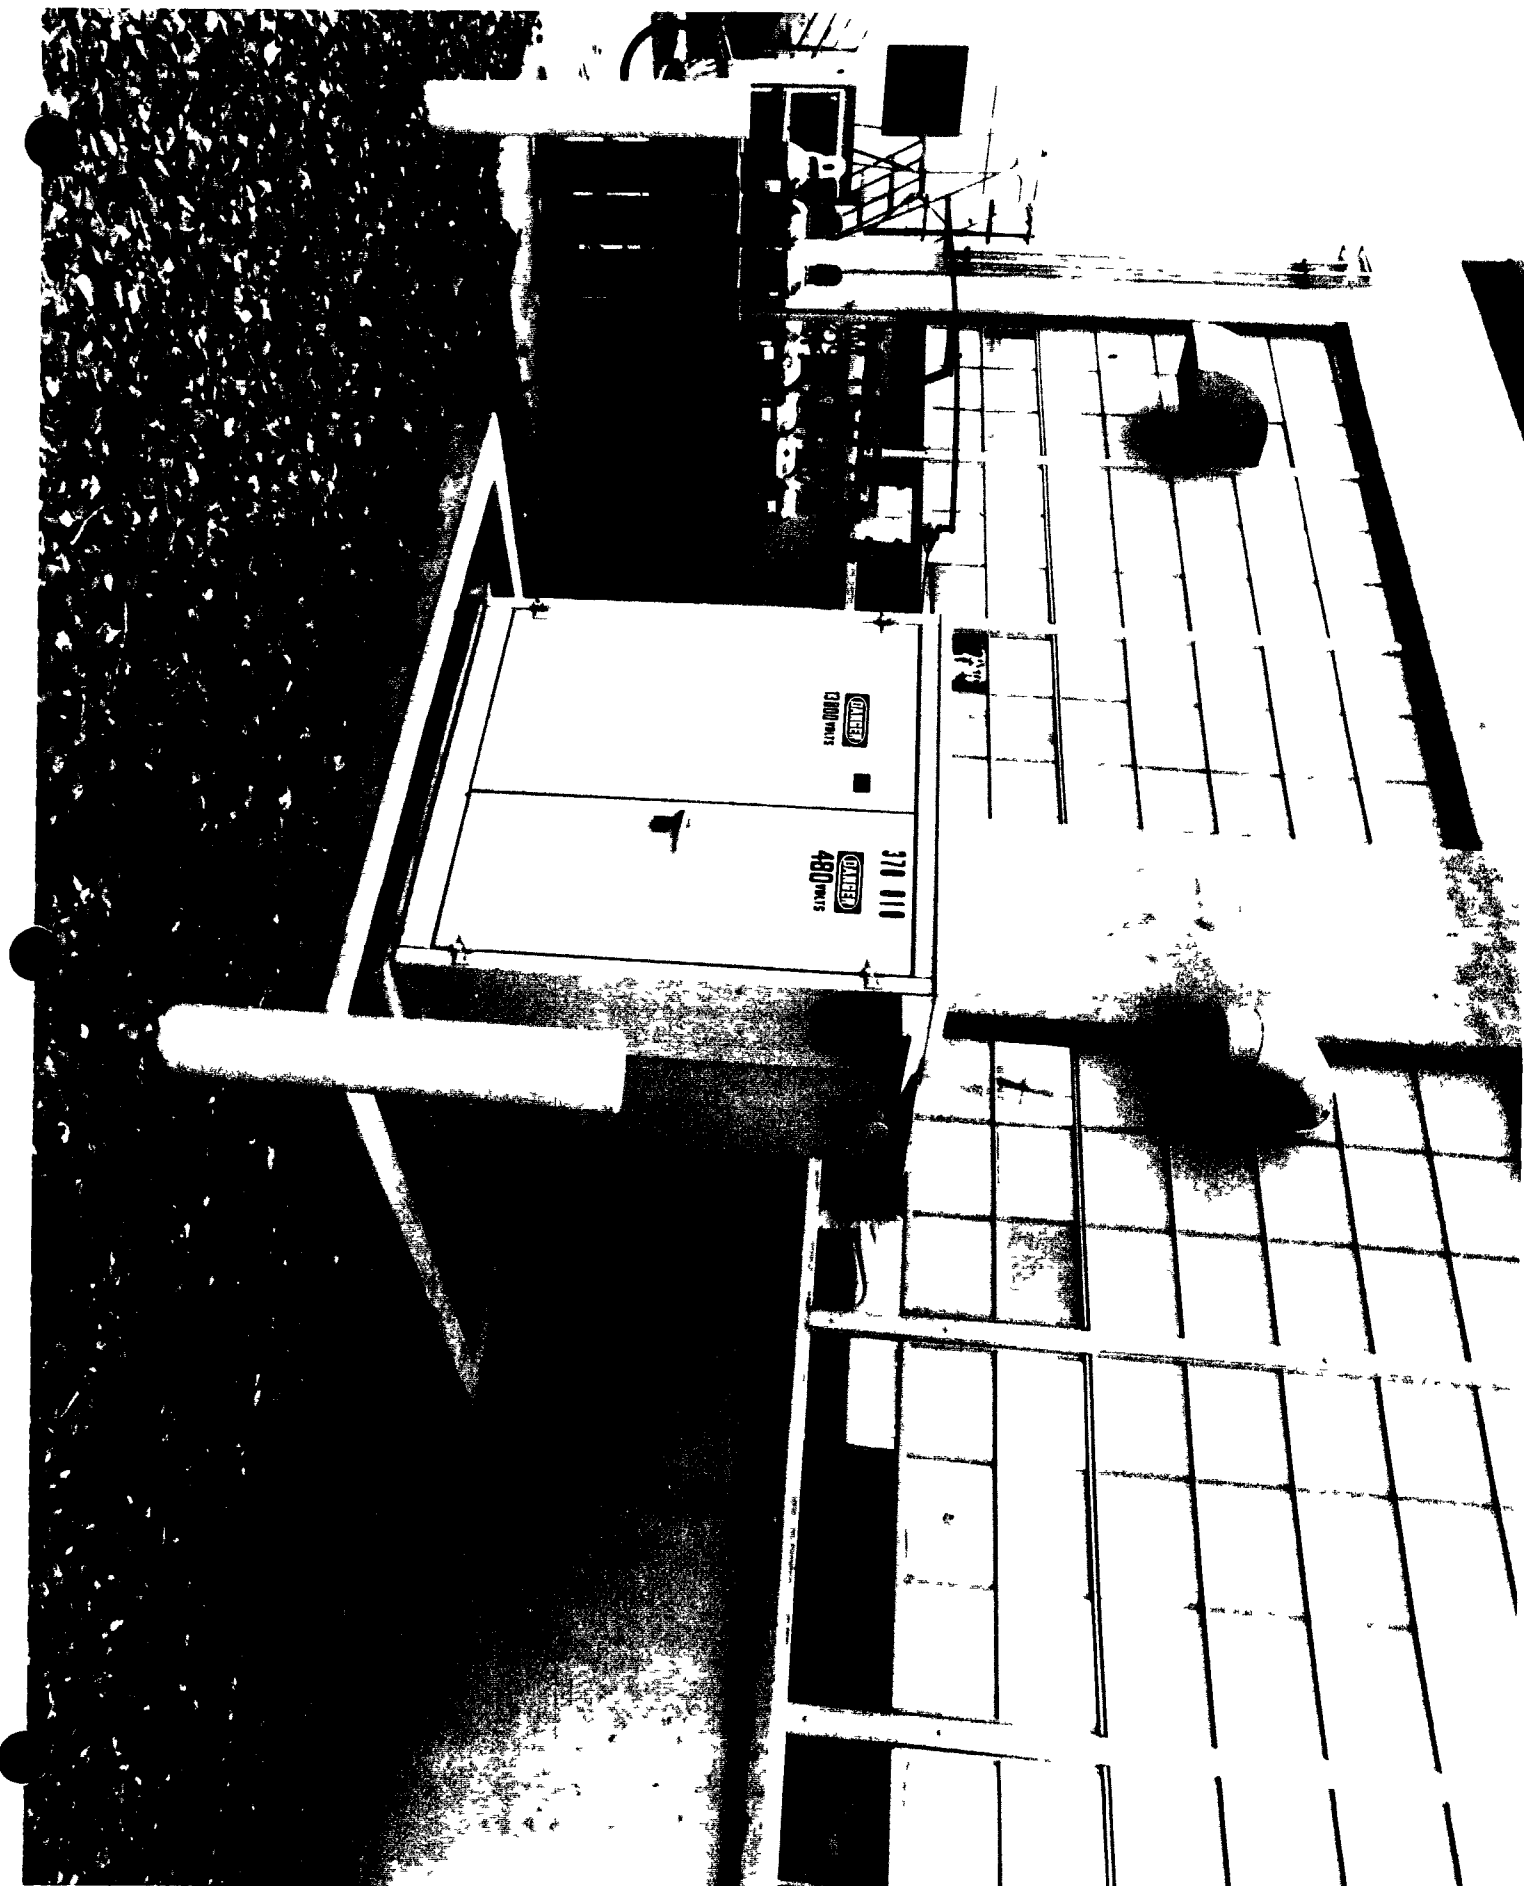
SITE #4 - Northwest of Building 334

Transformer 334-1 is presently located at this site (Photo #4). Past records kept by Utilities Electric indicate that Transformer 334-1 has had several prior locations. The transformer is situated on a concrete pad surrounded by 5 inches of gravel fill. A concrete berm is located around the pad. Transformer 334-1 was moved from another location prior to 1987, when it was retro-filled with non-PCB cooling oil. No spill or leak is known to have occurred at this location. The site is approximately 115 feet southwest of IHSS 181, 125 feet east of IHSS 156 1, 365 feet north of IHSS 190, and 360 feet northeast of IHSS 191 and is adjacent to the northwest corner of Building 334.

Site #4 is prioritized as a Category III.

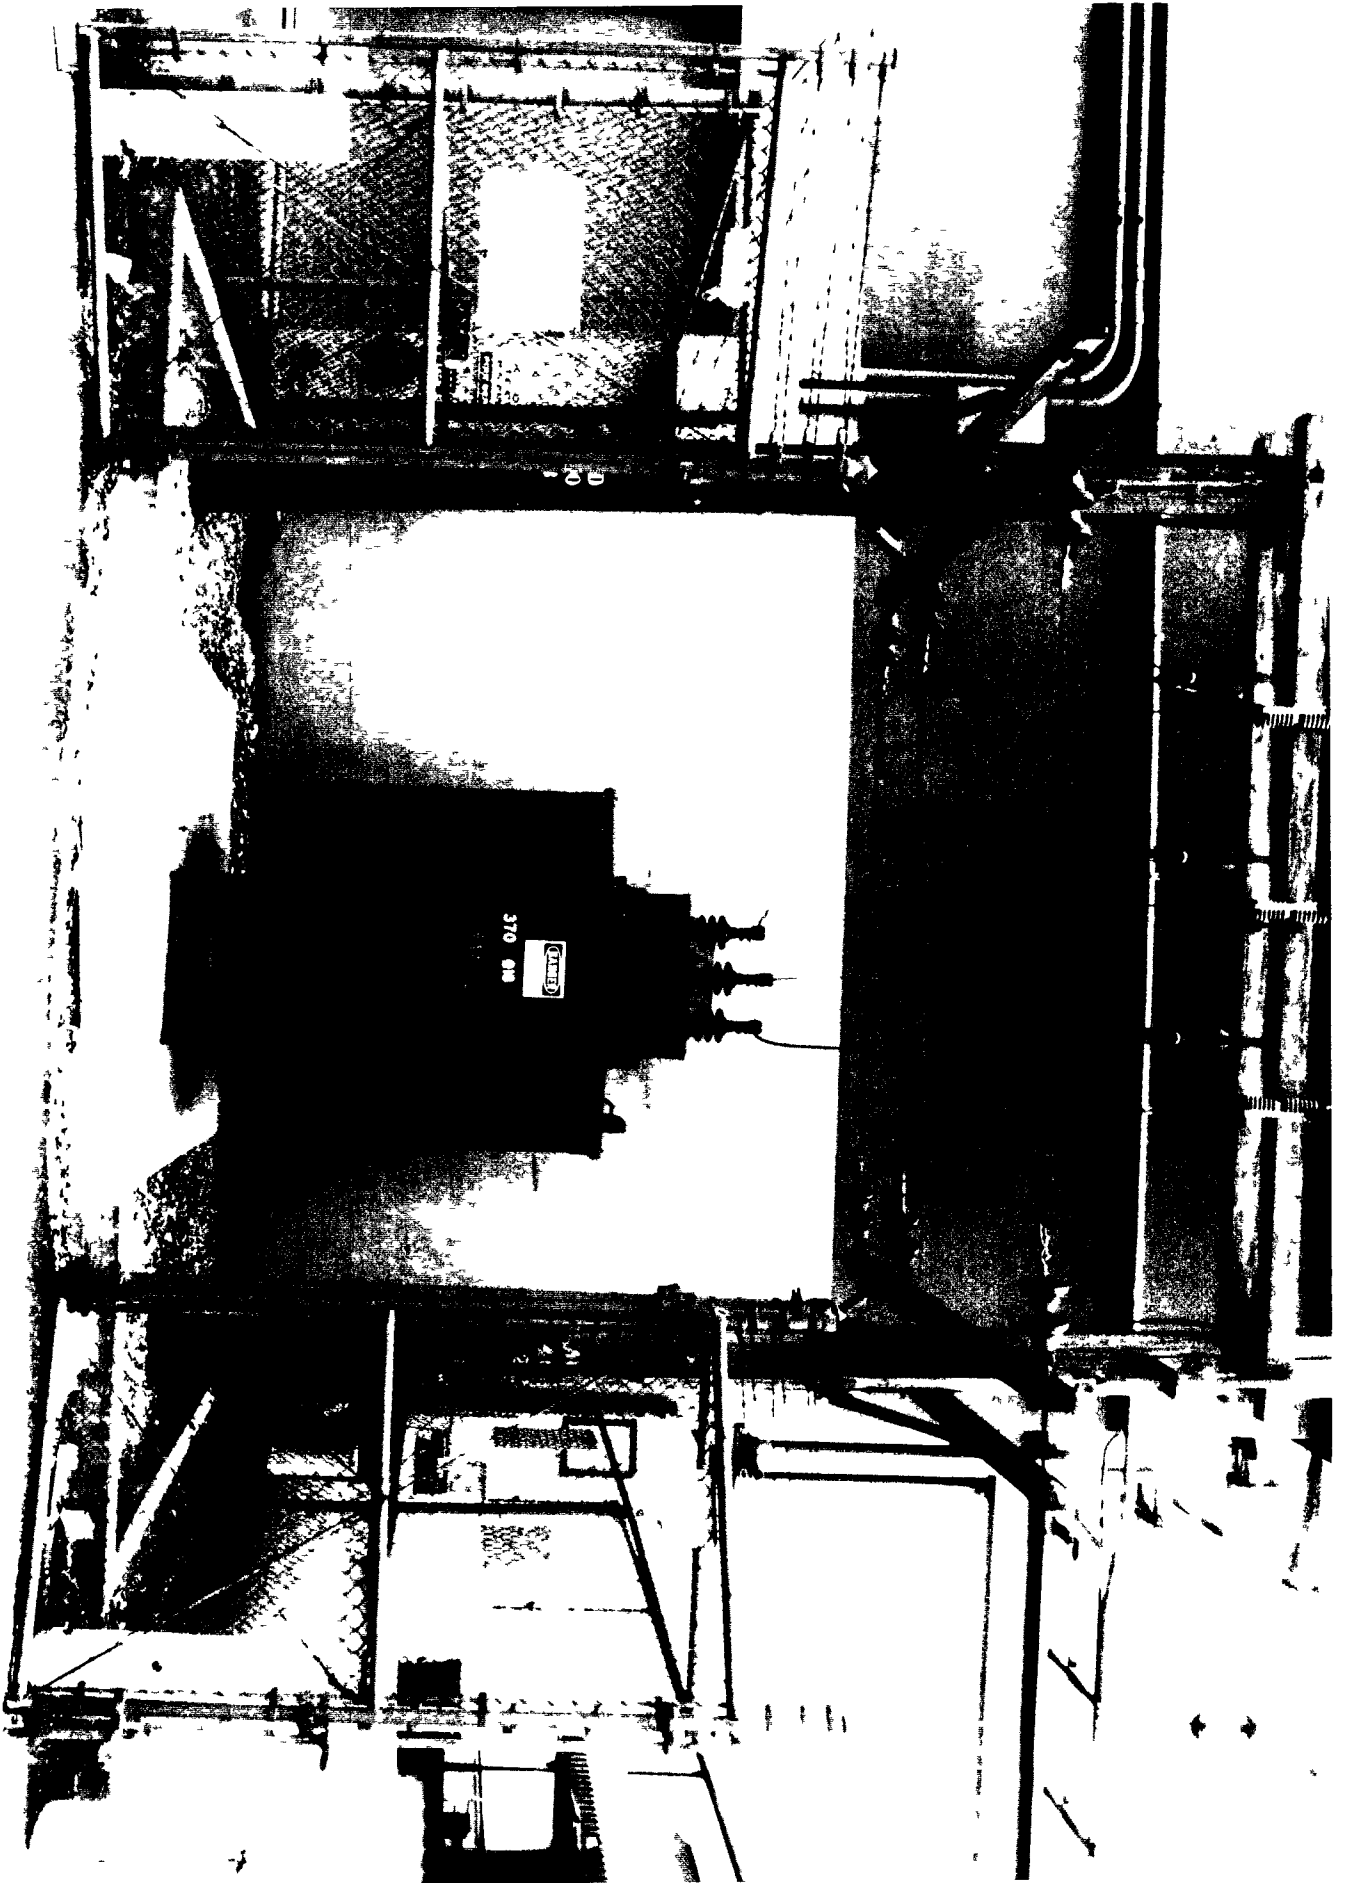
SITE #7 - Northwest of Building 444

Transformer 444-2 is situated on a concrete pad at this location (Photo #7) The pad is located adjacent to the northwest corner of Building 444 and is located in a bermed area containing rock fill. Currently, there is no information regarding the history of this transformer pertaining to any leaks or spills. However, documentation exists that indicate the transformer contains PCB cooling oil. There are no stains on the pad and no visible evidence on the surrounding gravel. This site is located forty feet north of IHSS 157 2 and approximately 165 feet northeast of IHSS 136 2.

Site #7 is prioritized as a Category III

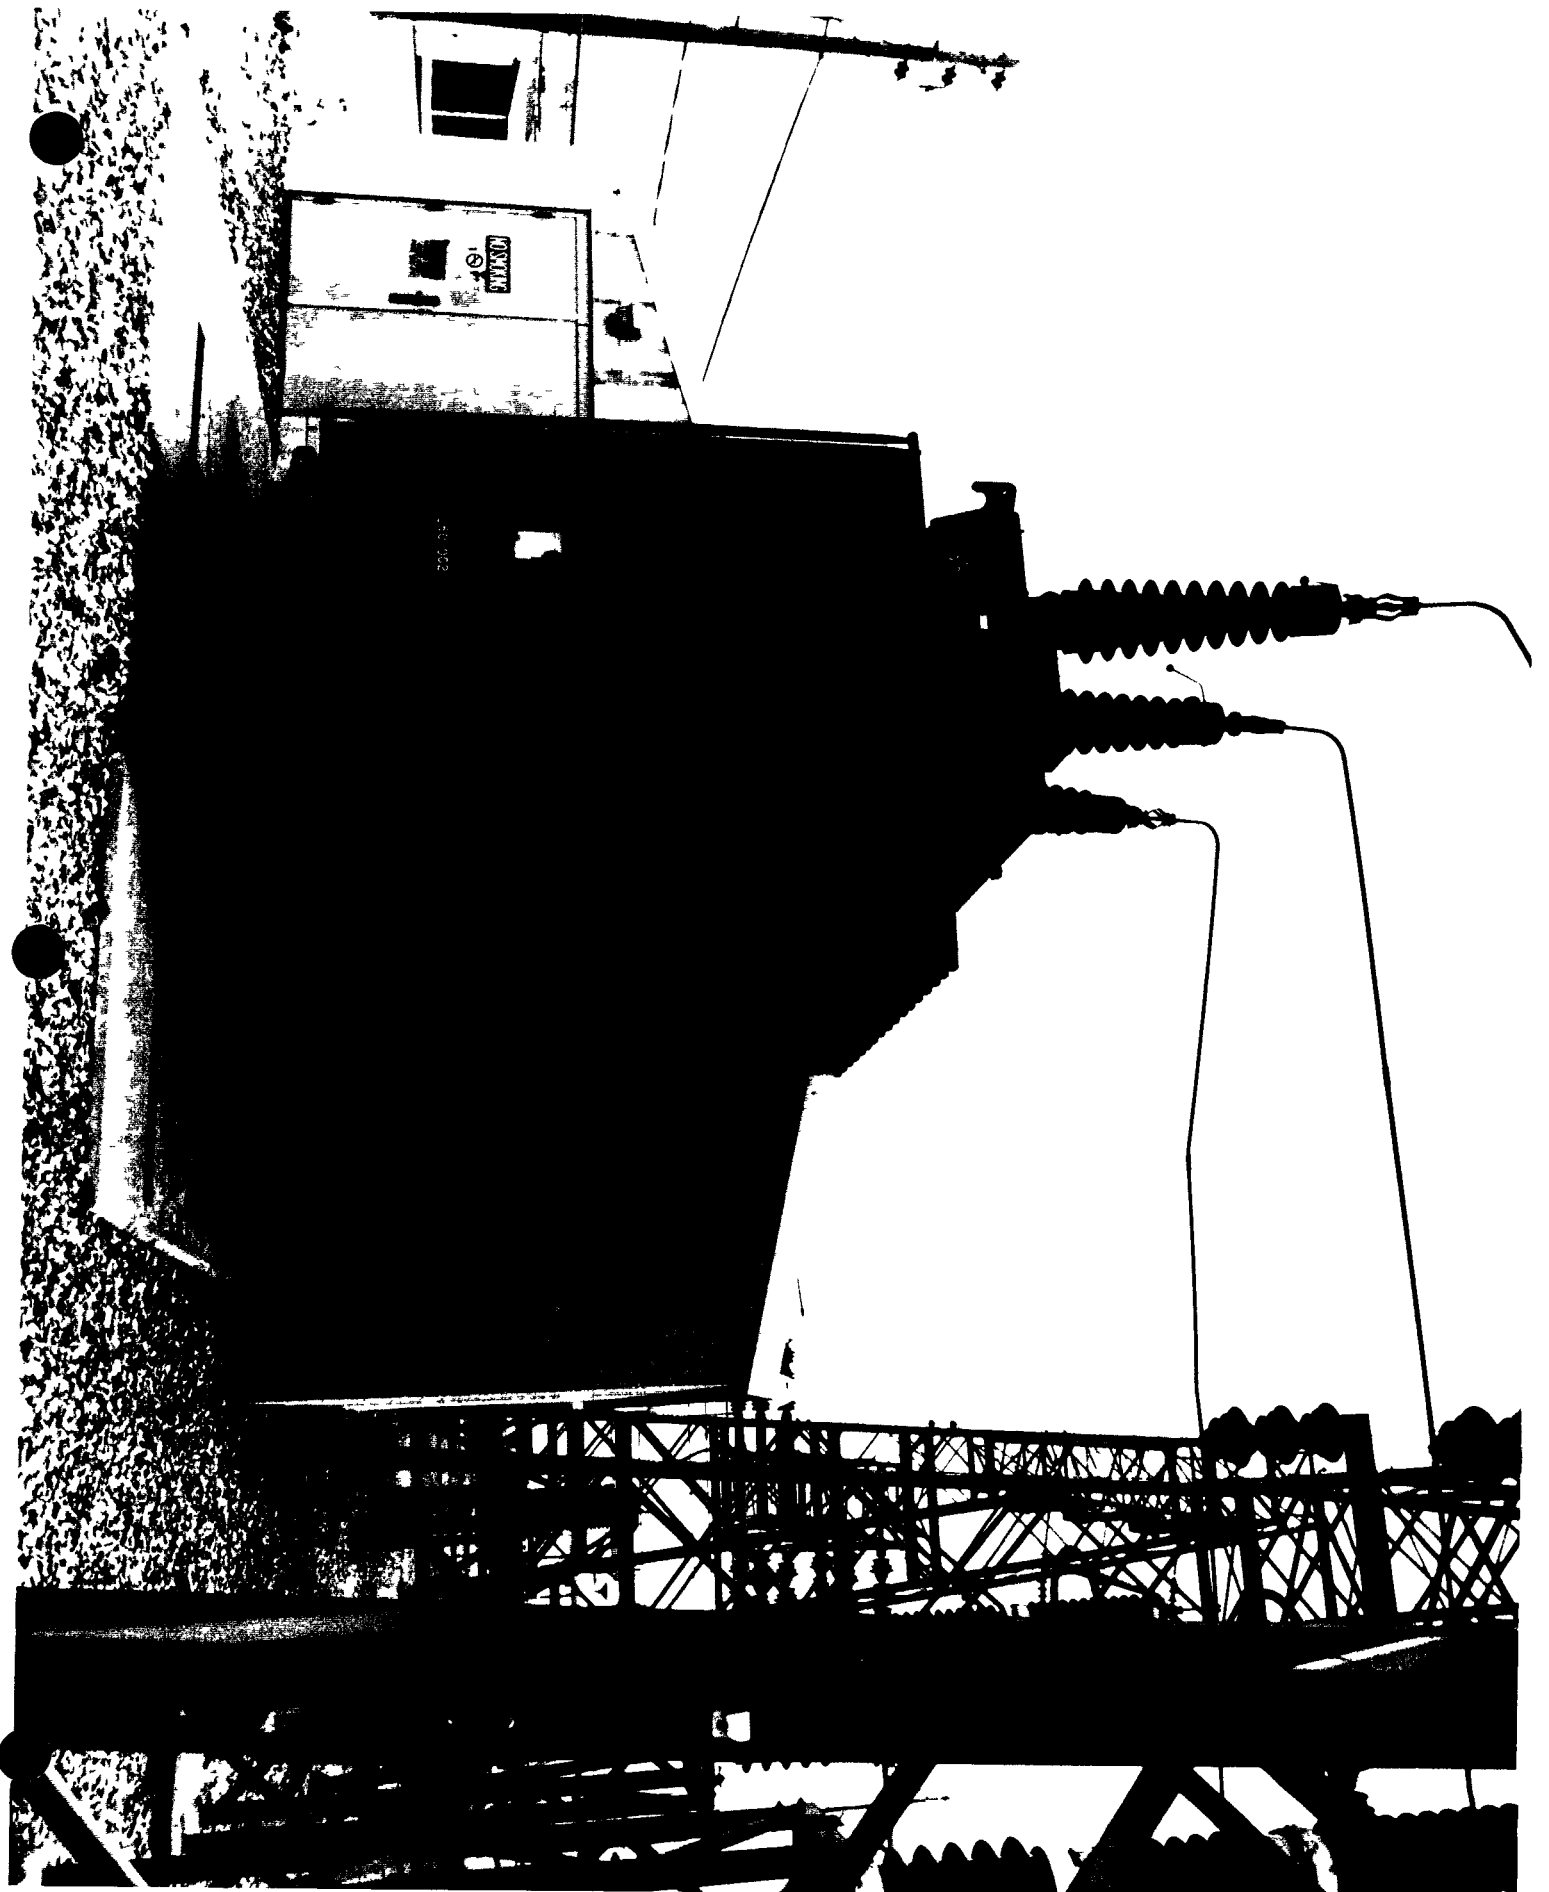
SITE #10 - North of 555-558 Substation

A valve on the east side of transformer 558 at this location (Photo #10) currently shows evidence of a leak around the valve. These observations were made during a site visit by EG&G/EMD personnel. The transformer is on the north side of 555-558 substation, and is located approximately 145 feet north of Central Avenue. It is not currently known whether this transformer was ever retro-filled as part of the 1987 program. The transformer is currently active and is situated on a concrete pad. There is no berm at this location. IHSS 172 (Central Avenue) is located approximately 145 feet to the south, and IHSS 190, which parallels Central Avenue, is located approximately 200 feet to the south.

Site #10 is prioritized as a Category II.

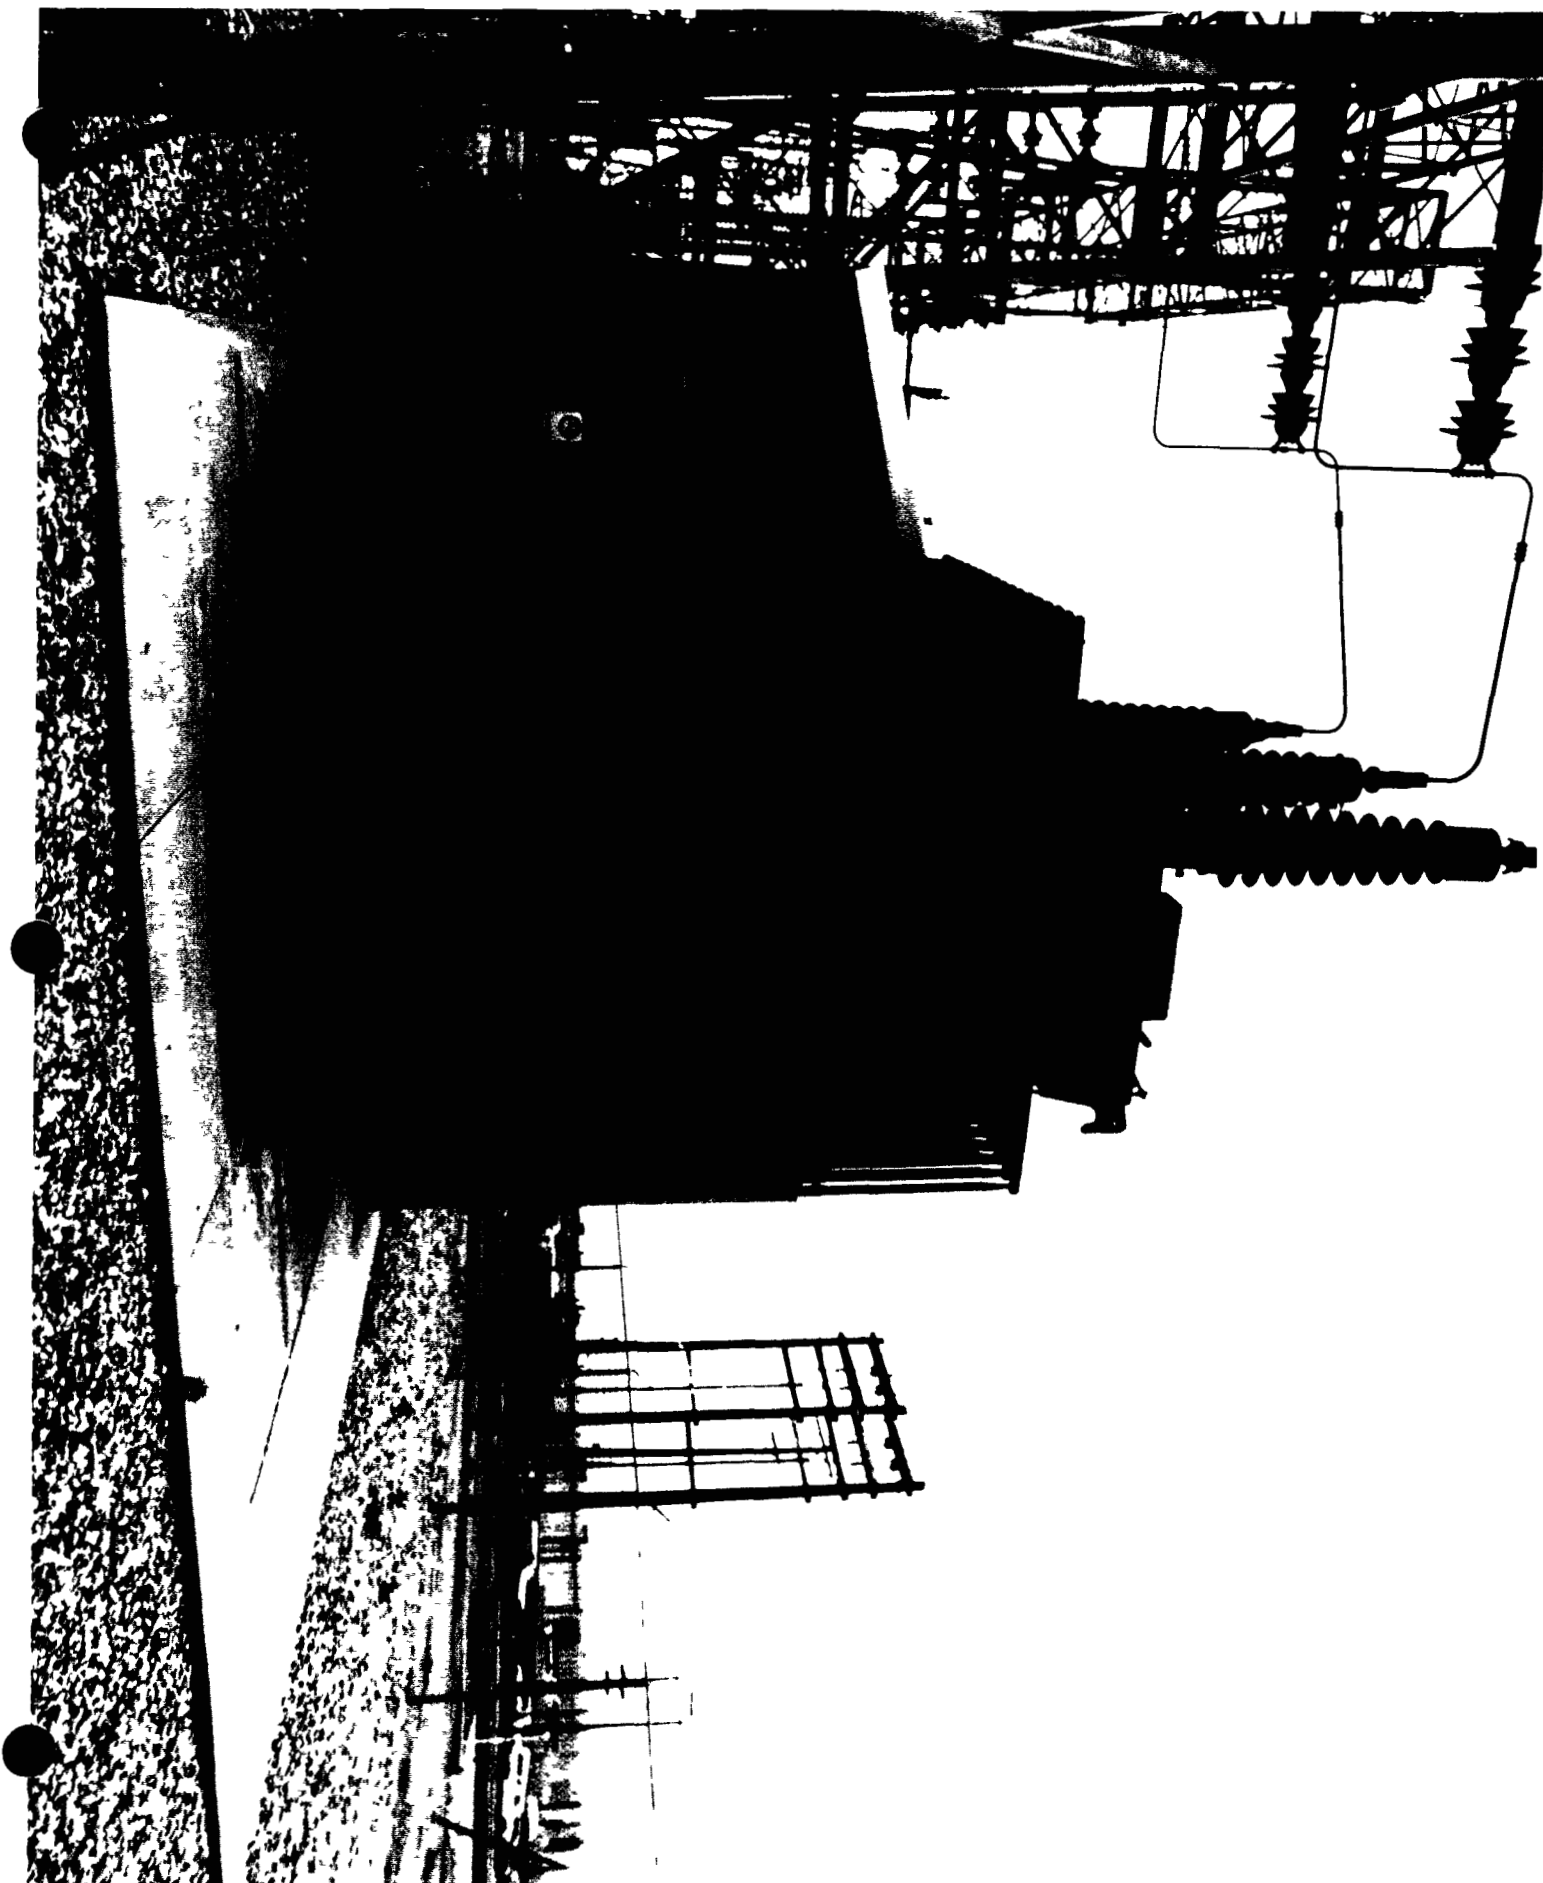
SITE #11 - South of 555-558 Substation

Transformer 555 is located on the south side of the 555-558 substation described in the site #10 site description. This transformer shows no evidence of leaking (Photo #11), and is believed to have been retro-filled in 1987. There is no berm or drains in the area. Rock fill was utilized around the pad. The transformer is active, and is situated on a concrete pad. The transformer is located approximately 25 feet north of IHSS 172 and 70 feet north of IHSS 190.

Site #11 is prioritized as a Category III

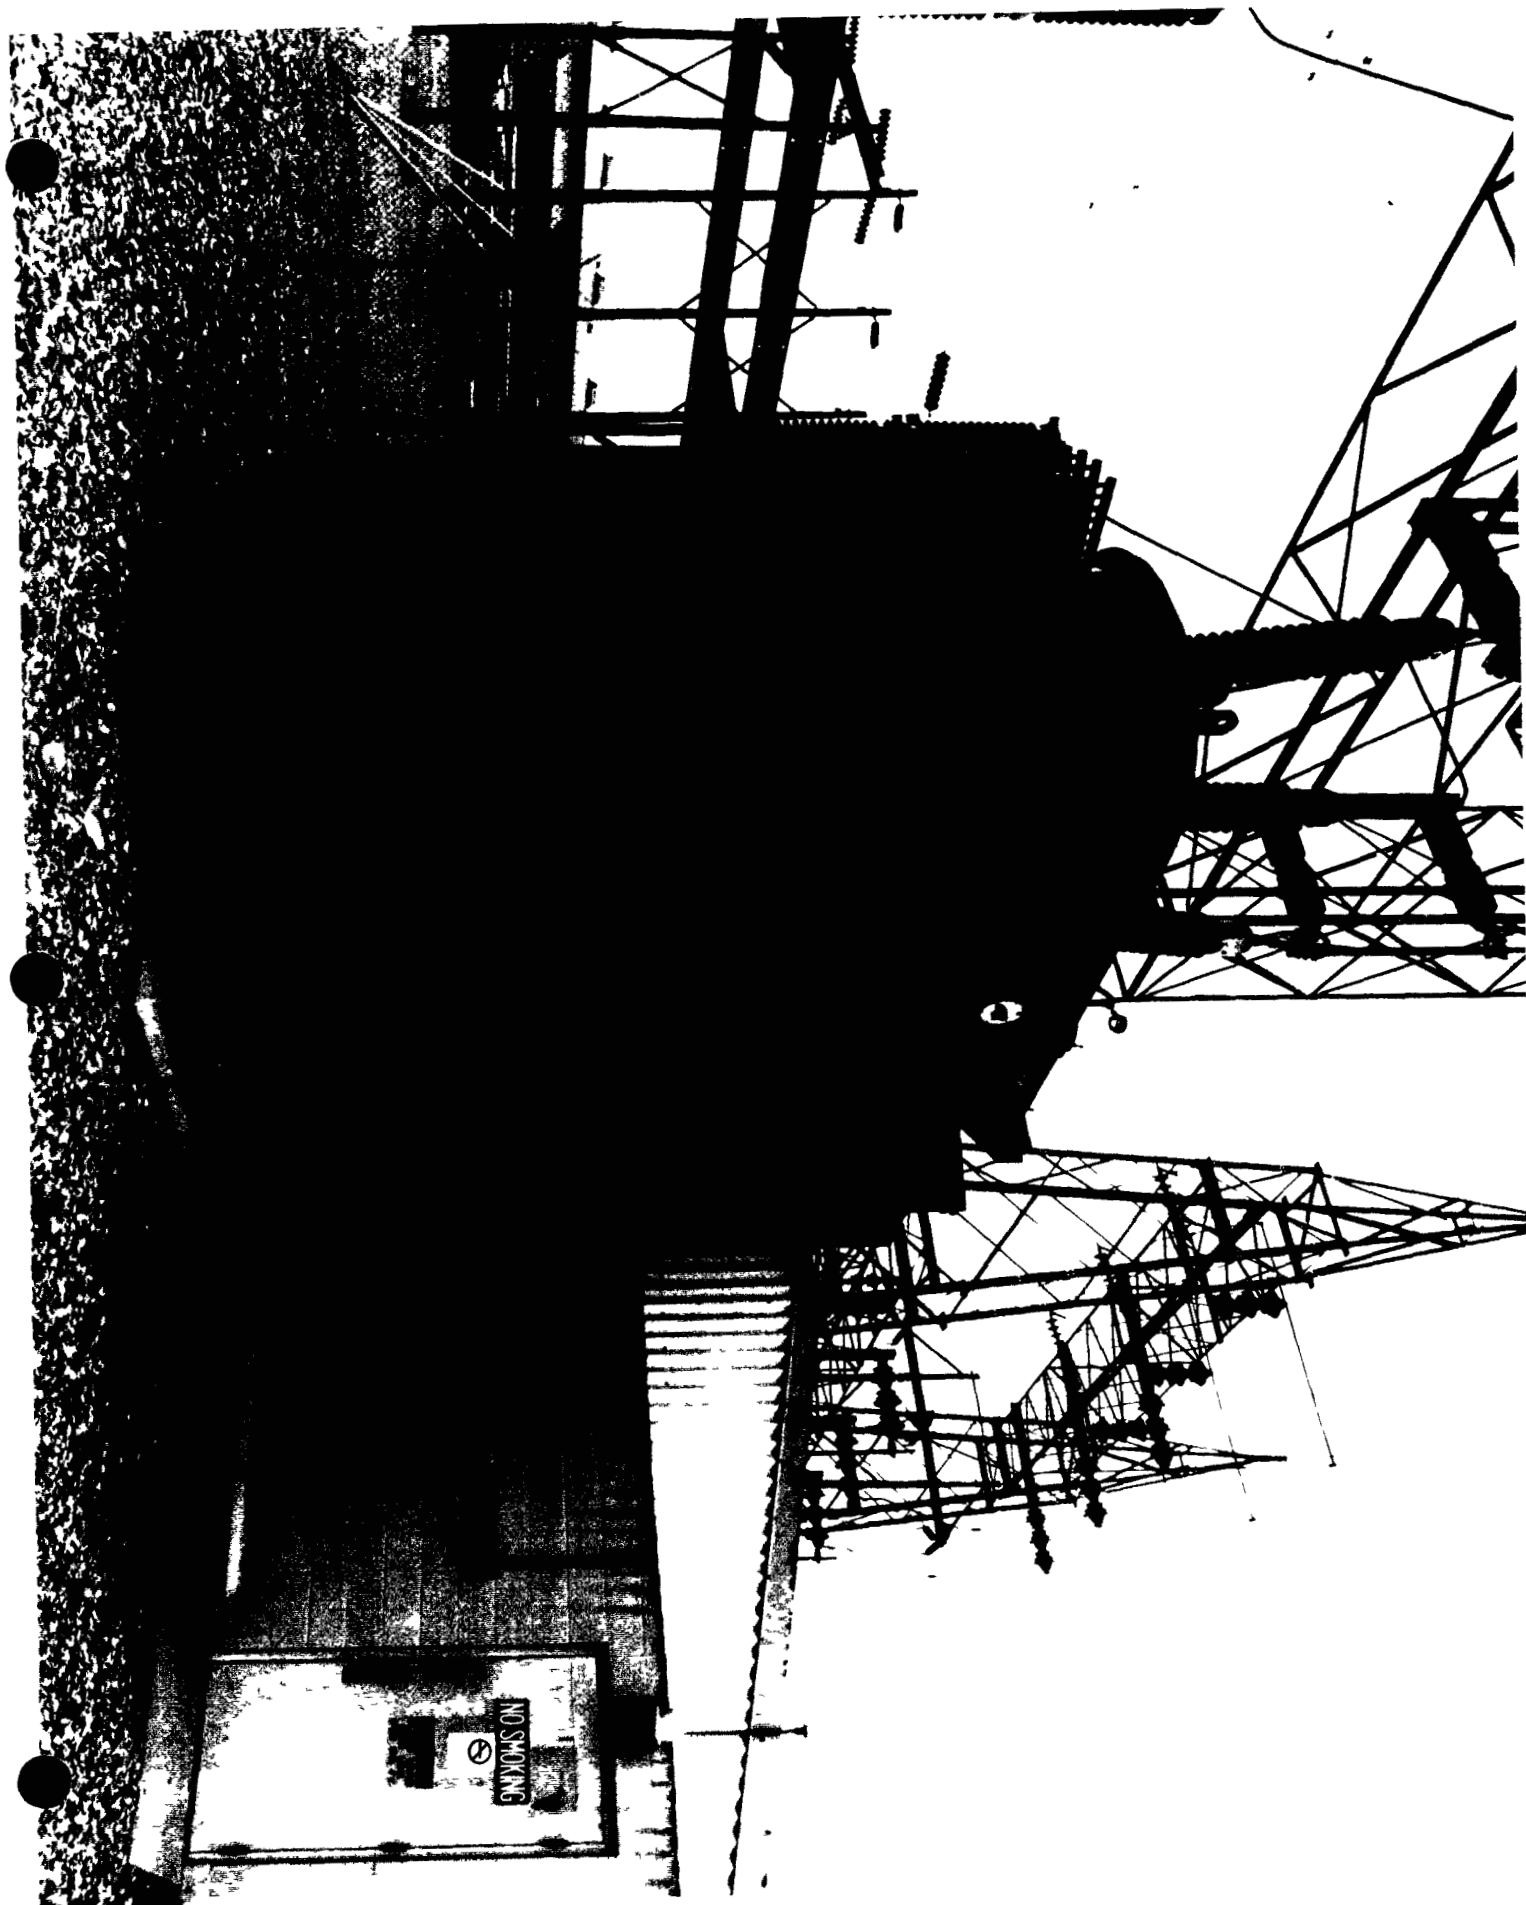
SITE #13 - South of 661-675 Substation

The transformer located at this site (350 004) shows no evidence of current leaking (Photo #13) Historical records indicate that the transformer leaked prior to 1987 according to conversations with Utilities personnel The cooling oil was sampled in 1987 after retro-filling was complete and the results were below 50 ppm The transformer is currently active and is situated on a concrete pad several feet south of the 661-675 substation There are no drains in the area or berm around the pad There is rock fill around the transformer area

Site #13 is prioritized as a Category II
